CASE STUDY: Crushed Stone

TIVAR® 88 High Performance Lining Solution

TIVAR® 88-2 RAILCAR END WALL LINERS ENHANCE AGGREGATE FLOW, REDUCE COSTS

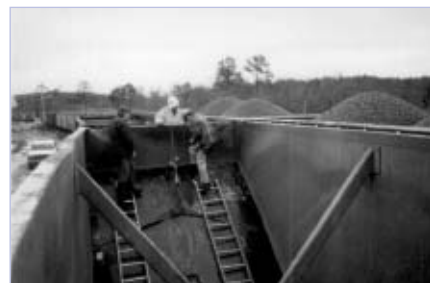
TIVAR® 88-2 end wall liner installation in progress.

Solution: Due to its low coefficient of friction, abrasion resistance and corrosion resistance, 3/8"-thick TIVAR® 88-2 end wall liner kits were selected to line the end walls of the railcars to enhance the flow characteristics of the car.
