CASE STUDY:

Lignite Coal

TIVAR® 88 High Performance Lining Solution

TIVAR® 88-2 LINERS IMPROVE BOTTOM DUMP RAILCAR OPERATING EFFICIENCY

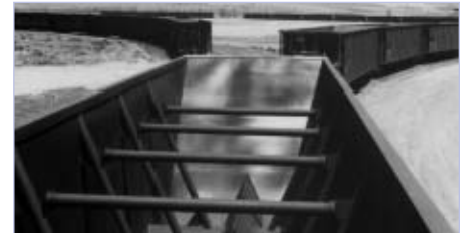
Basin Electric railcars with TIVAR® 88-2 liners installed.

Solution: The plant first opted to try TIVAR® 88-2 linings on the sloping end walls of 50 hopper cars. Although coal discharge improved notably, during the winter months, 2-3 tons of material would accumulate on the cross beams each trip, and with a standard two-trips-per-day schedule, build-up remained costly. Next, the utility designated two bottom dump railcars to test complete lining systems. Quadrant Engineering Plastic Products SystemTIVAR® team designed linings for the discharge doors and structural support components, including cross beams and center sills. Using thermoforming and proprietary welding techniques, the Quadrant Engineering Plastic Products team pre-fabricated linings using 3/8" TIVAR® 88-2 UV-resistant material. A certified SystemTIVAR® installation contractor installed one railcar lining each day.

Results: Tested in year-round weather conditions, the 100-ton capacity cars showed less than 1/16-ton carryback - an insignificant amount as deemed by the utility. Turnaround times at the raildump receiving bunkers have been cut by as much as 50% and loads are effectively discharged without the frequent use of car shakers, thawing sheds or other techniques that fatigue railcar structures.
